## A LARGE OAK JACOBEOAN STYLE PANELLED ROOM

a copy of the State Room (c.1606) at the 'Old Palace', Bromley-by-Bow, former hunting lodge of King James I,

STOCK CODE: 75281

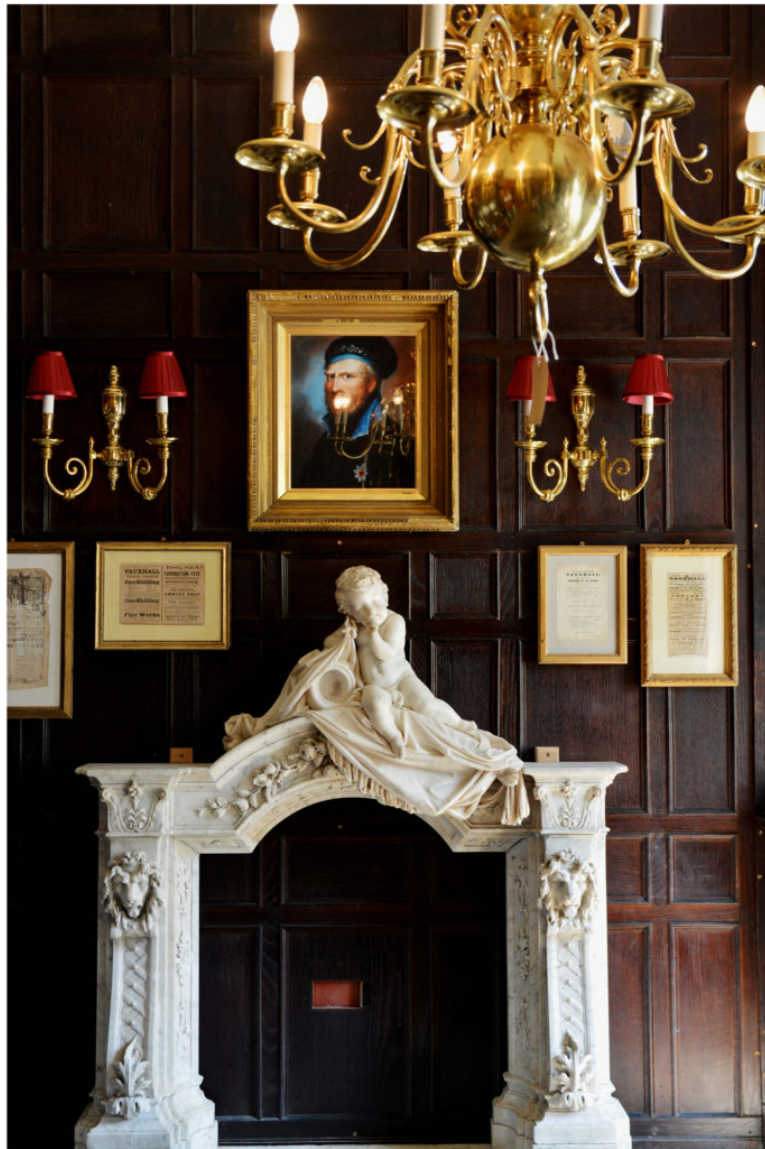
Currently re-erected in the British Galleries at the Victoria and Albert Museum. The panelling of pegged construction, with eleven Doric pilasters having blind-fretwork of intertwining strap-ornament carved in low-relief, the elaborate cornice of conforming strap-work frieze surmounted by dentil and ogee mouldings, early twentieth century. Twelve panels 231cm/91" wide, overall height of the panelling including cornice 371cm/46", the pilasters 46cm/18" wide each. Various smaller panels available.
